Title of Action: Volunteer Management & Development Company Inc vs. State Auto Property & Casualty Insurance Company

Document(s) Type: Summons/Complaint

205 RINGO DRIVE, CLINTON, KY 42031

1230 SOUTH ELLINGTON PARKWAY, LEWISBURG, TN 37091

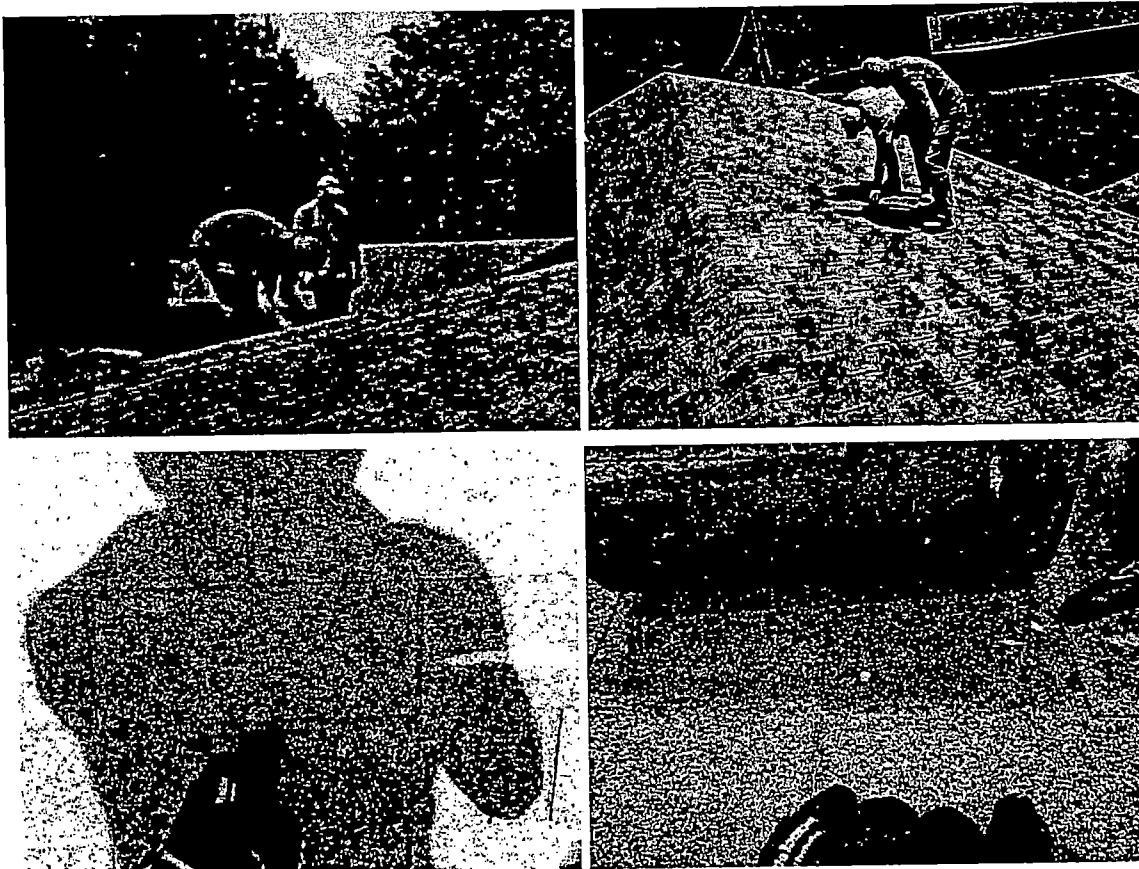
- The roofs were believed to be 20 years old or older.
- Large exterior damage was reported to the complex after high winds in December 2021.
- During a joint inspection of the roof covering on Building 1, Mr. Griffin was observing a shingle tab on the east-facing slope within the field of the roof slope. It appeared Mr. Griffin was manipulating the shingle in order to observe underneath the shingle. Mr. Griffin stated the dirt beneath the shingle was wind damage. The shingle tab contained a diagonal crease from the side of the tab that was fresh in appearance and occurred when Mr. Griffin lifted the shingle, delamination of the sealant strip, and still had tacky adhesive present. The shingle tab was clear of damage consistent with wind forces.

Figures 11 through 14 – Joint Inspection Photos THIS IS LIBEL

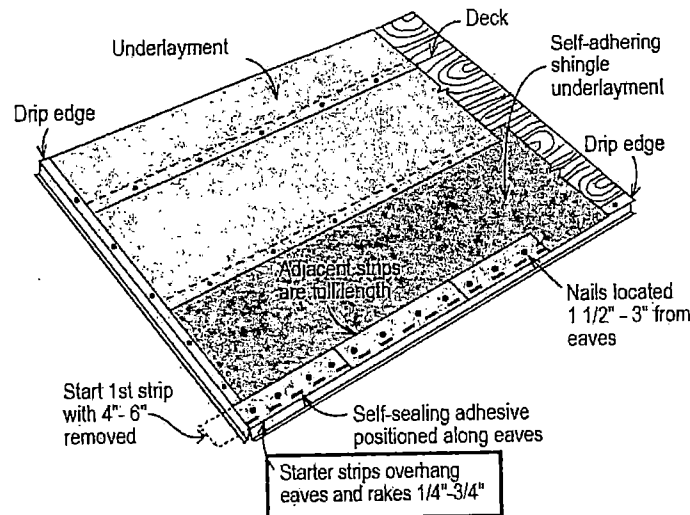
Figure 19 – ARMA Shingle Installation

The subject buildings had shingles installed with up to ~1-1/2" hanging into the gutter. This rendered the shingles susceptible to improper bonding. Improperly bonded shingles can be susceptible to wind damage at below design wind speeds. During EES' inspection, many shingles contained damage as a result of improper installation along the eaves.

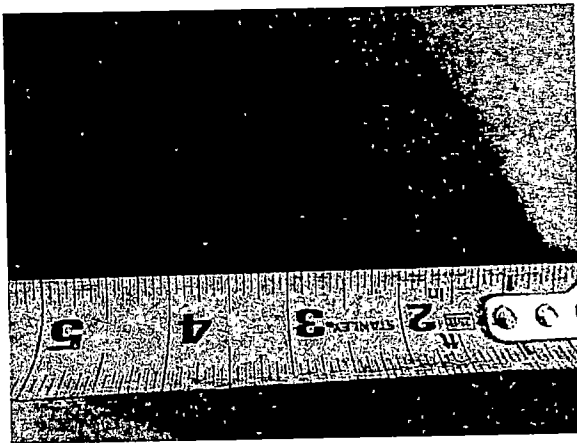
Building 1 – Roof – Spatter on West Slope

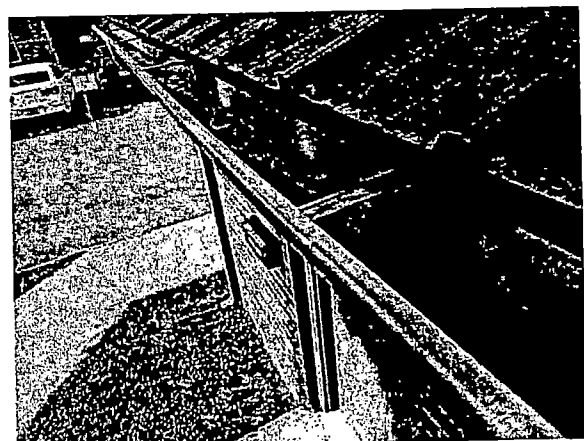
Building 1 – Roof – No Damages

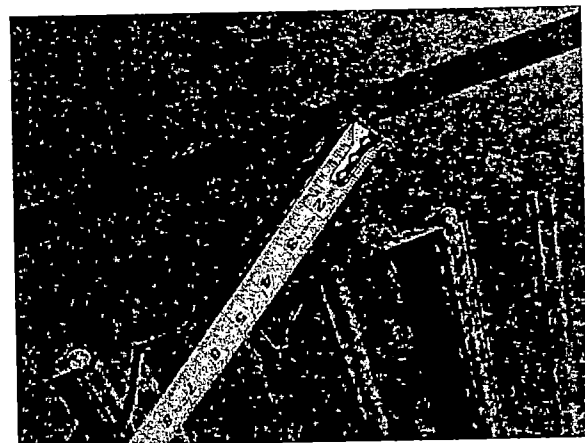
Building 2 – Roof – Spatter, No Damage

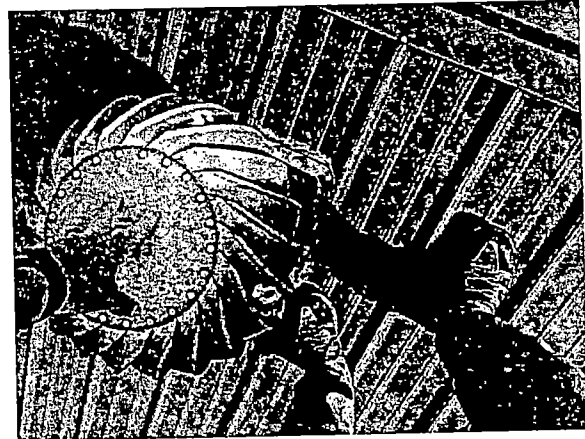
Building 2 – Roof – Dents to Turbine Vents

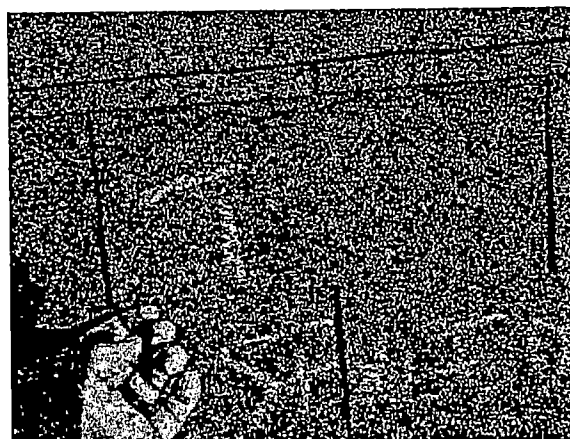
Building 1 – Roof – South Slope Torn Shingle Sealed

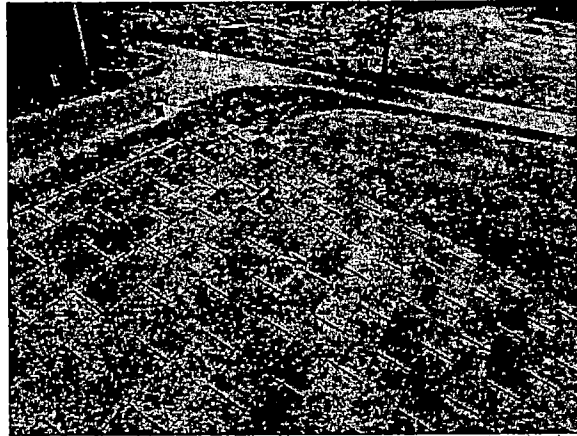
Building 4 – Roof – Missing Tab on South

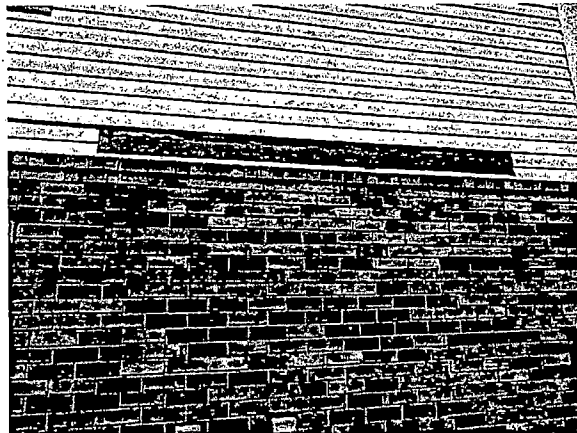
Building 4 – East Exterior – Missing Siding

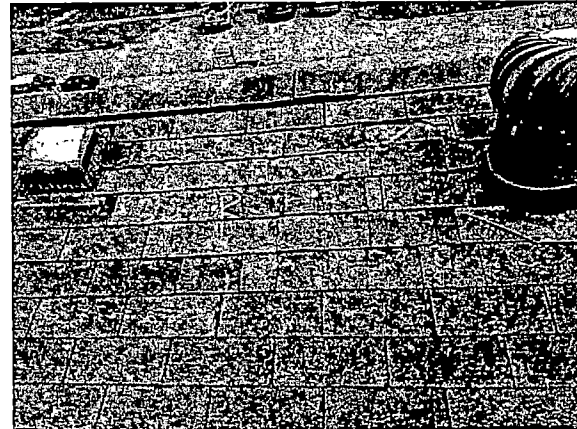
Building 4 – Roof – Missing Tab on South Near Replacement

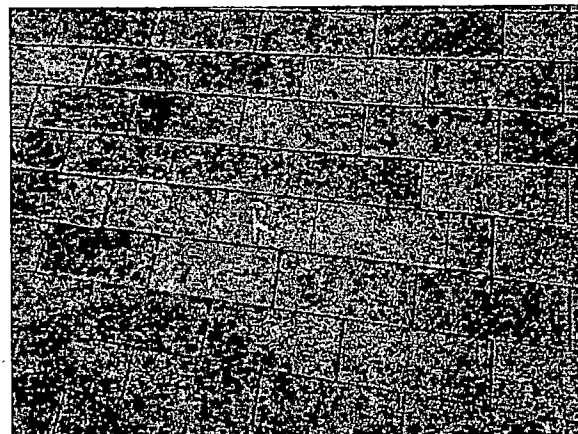
Building 4 – Roof – South Slope Replacement

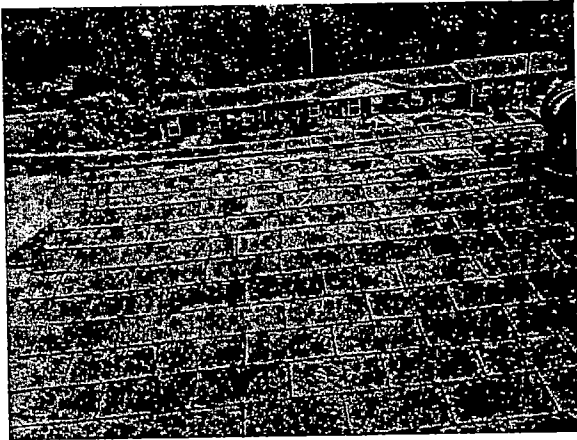
Building 4 – Roof – South Slope Replacement with Missing Tab

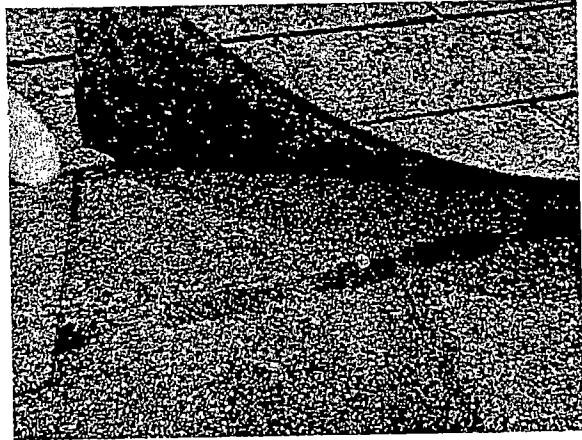
Building 4 – Roof – North Slope Torn with Delamination

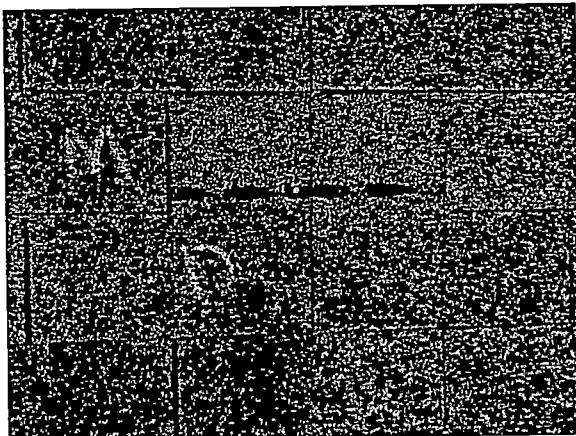
Mail Room – Roof – North Slope Missing Tab

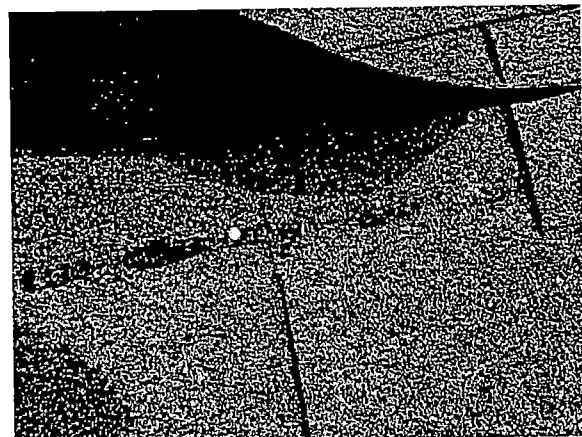
Mail Room – Roof – South Slope Creased Tab with Delamination

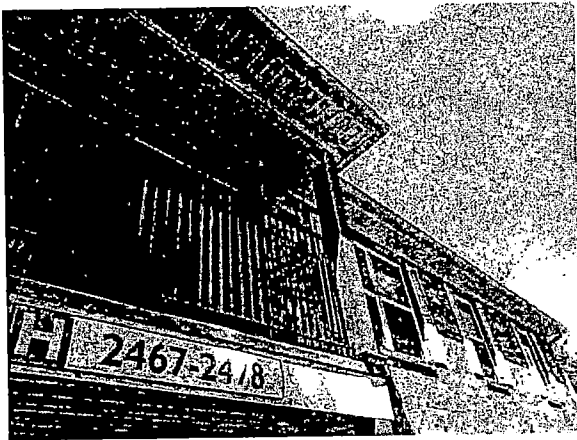
Building 1 – South Exterior Soffits Hanging

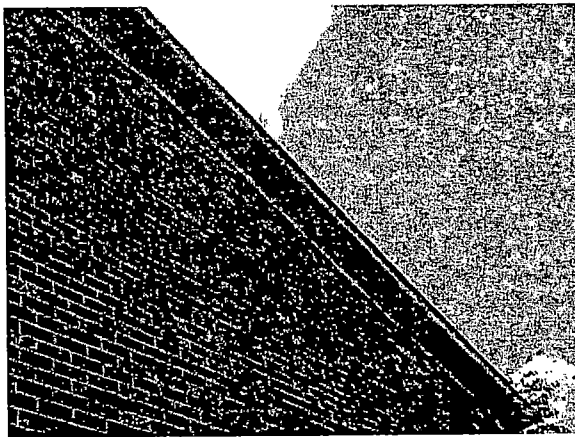
Building 4 – East Exterior Missing Soffit

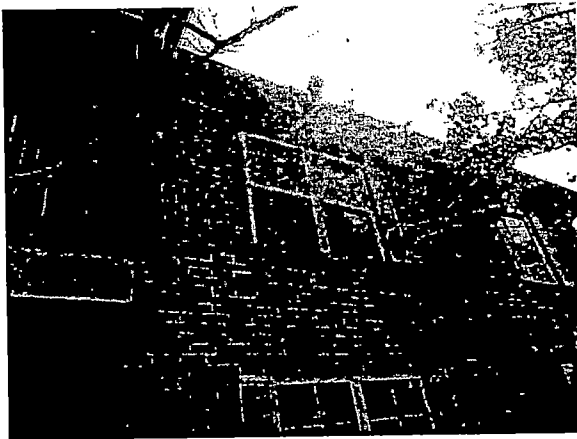
Building 5 – North Exterior Missing Shutter

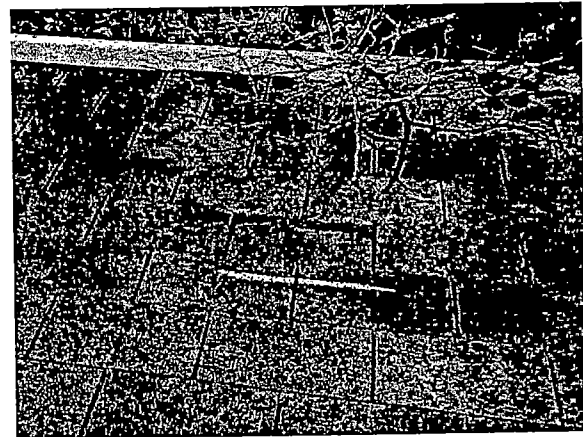
Building 5 – North Slope Tree Damage

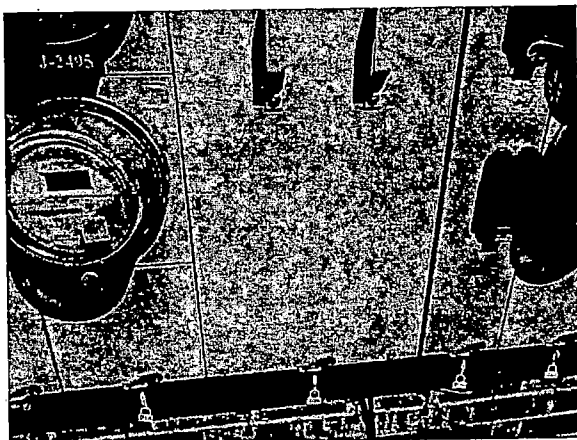
Building 5 – West Exterior Spatter Marks

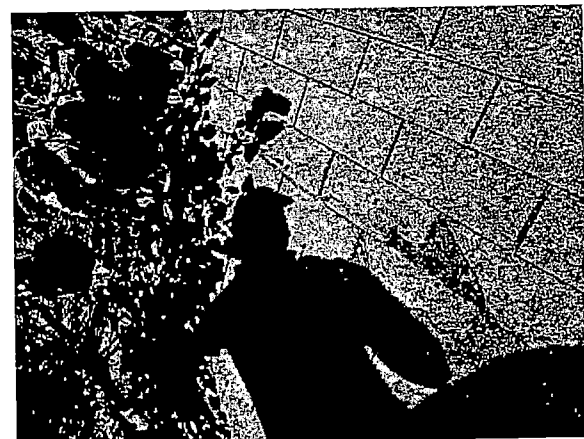
Building 5 – North Slope Tree Damage

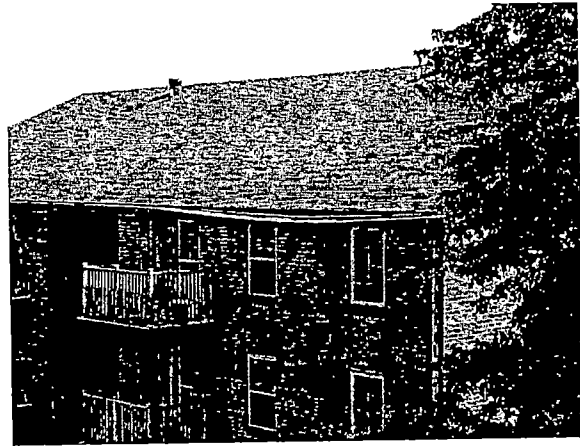
Building 6 – Gutter Damage on South Elevation

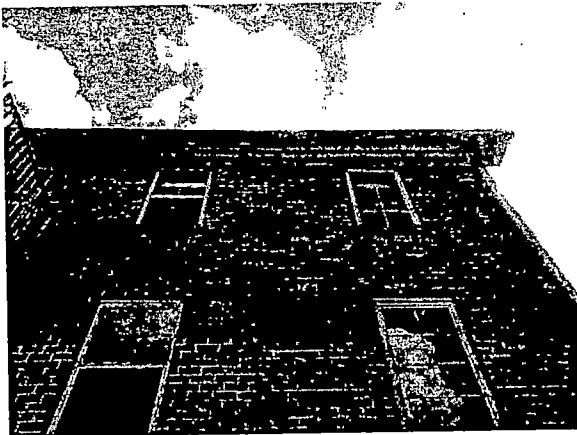
Building 6 – Missing Soffit on North Elevation

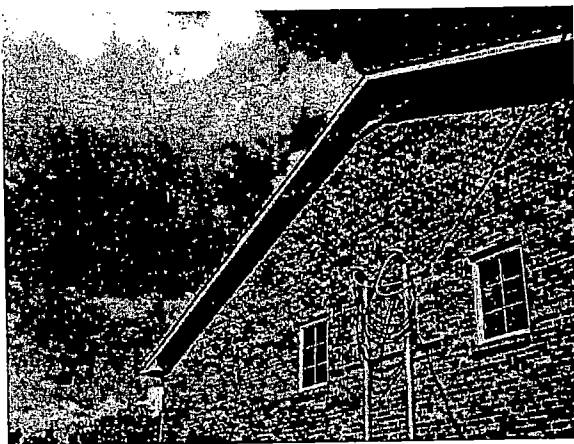
Building 6 – Missing Soffit on West Elevation

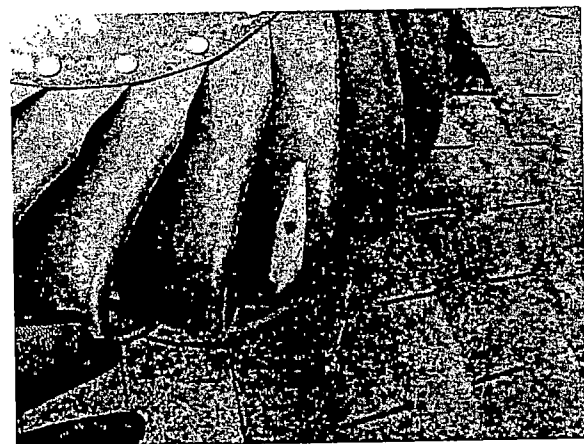
Building 6 – Dents to Turbine Vents

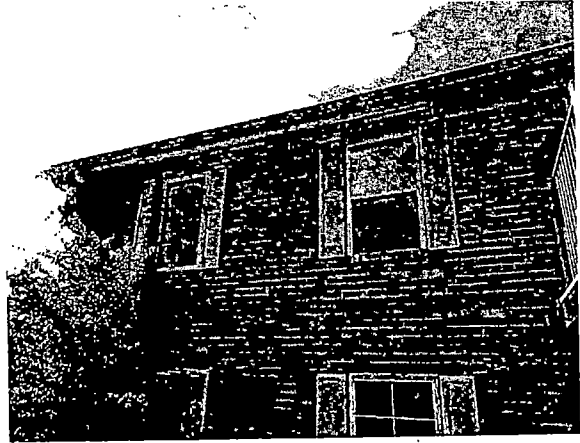
Building 7 – South Missing Soffits

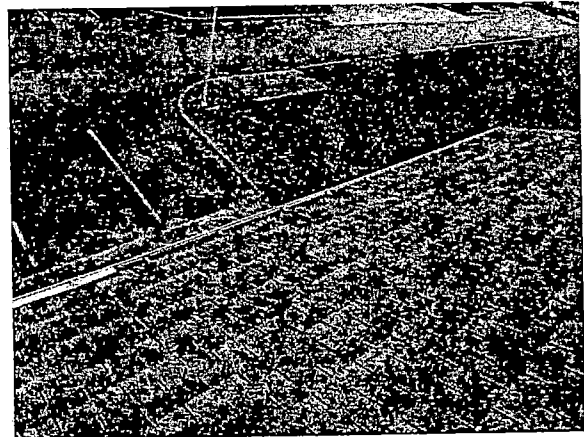
Building 7 – South Missing Gutter Guards

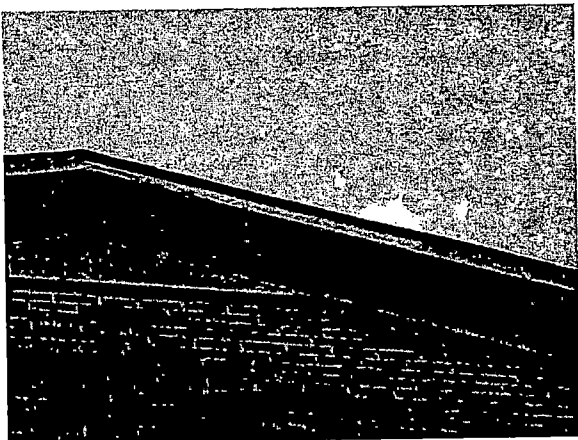
Building 7 – East Missing Soffits

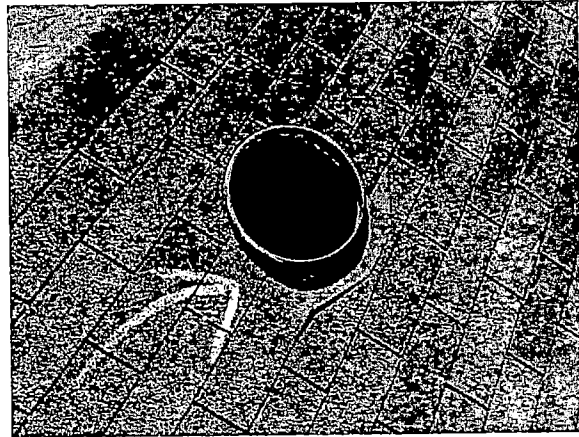
Building 8 – Missing Turbine Vent

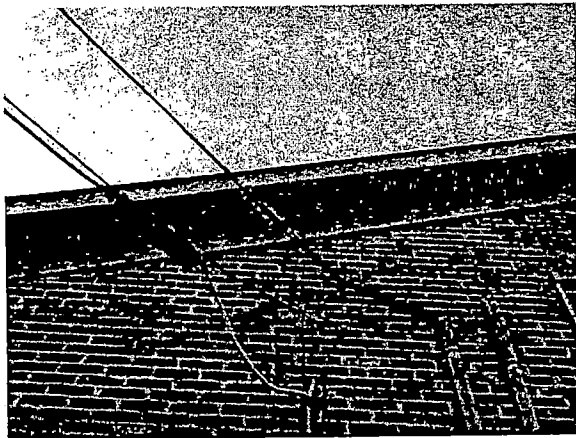
Building 8 –East Soffits Missing

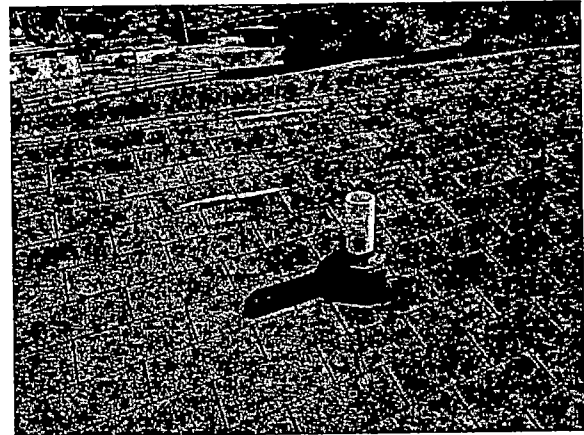
Building 9 – Mechanical Damage on North

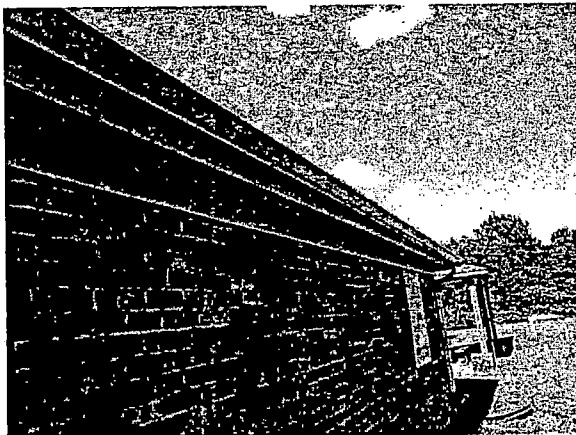
Building 9 – Hanging Soffit – South

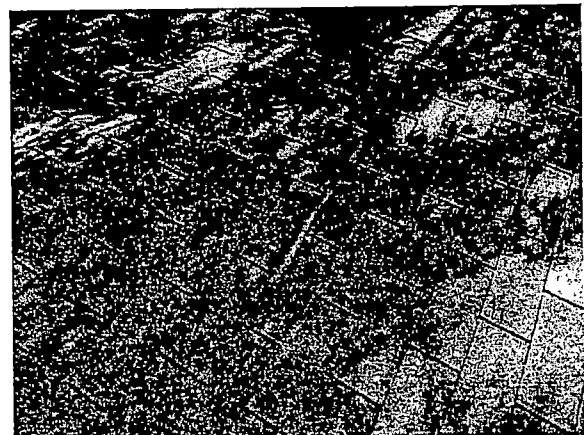
Building 9 – Mechanical Damage on South

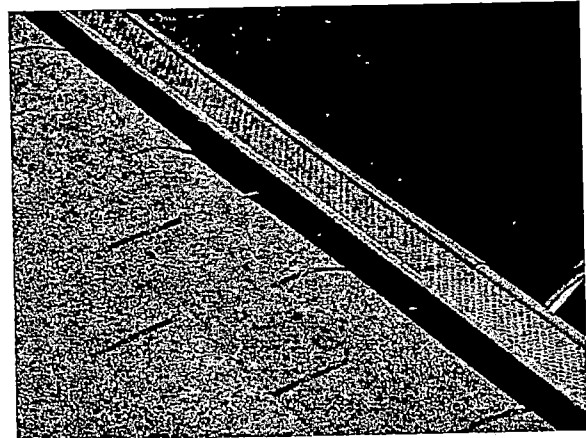
Building 10 – Gutter Pulled Away and Replacement Gutter Guard

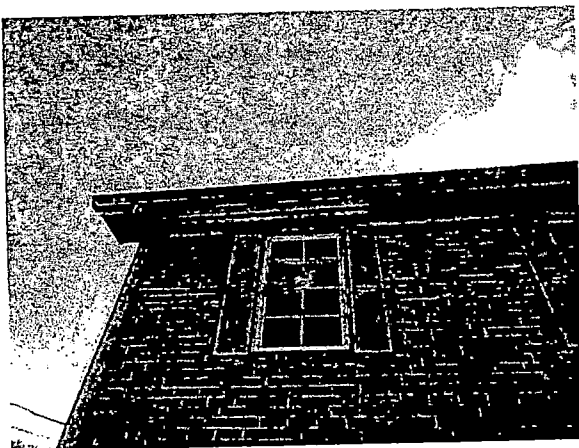
Building 11 – East Missing Soffits

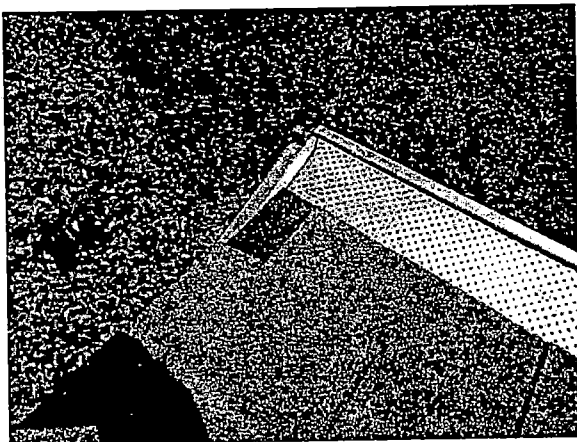
Office – Missing Partial Shingle
